RIVERPORT
SOCIEDAD PORTUARIA

Environmental Compliance Report

1st Semester 2024

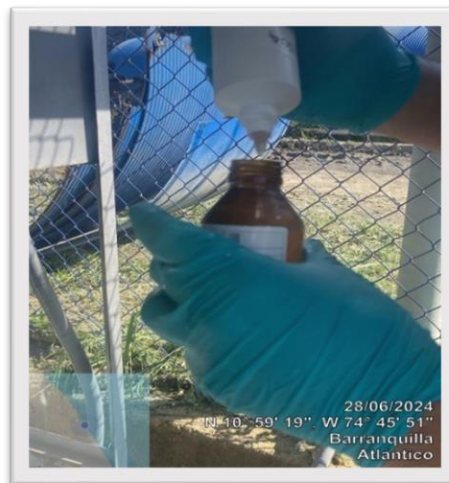
Imagen No 5 y 6. Monitoreo Semestral Agua Superficial

Characterization of one of the surface water intake points, following the requirements established in *Resolución 0380 del 2020*. This monitoring was conducted from June 27 to 29. The results obtained are as follows:

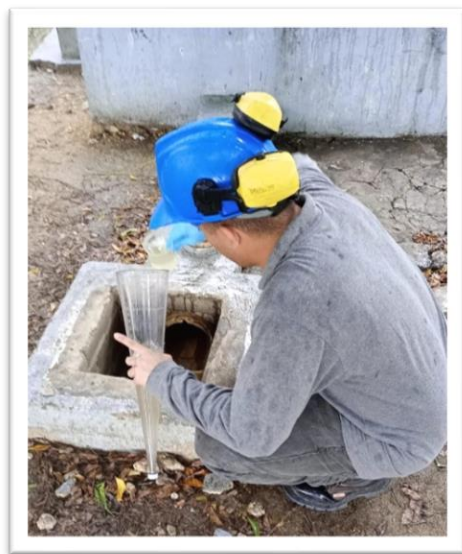
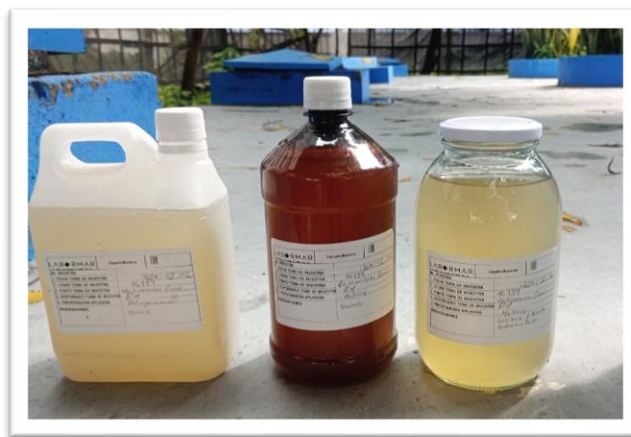
Imagen No 7 y 8. Monitoreo Semestral

During this semester, characterization was performed at the discharge point for domestic wastewater discharges, based on the evaluation of the parameters defined in Article 8 of *Resolución 631 del 2015*. The results obtained are shown below.

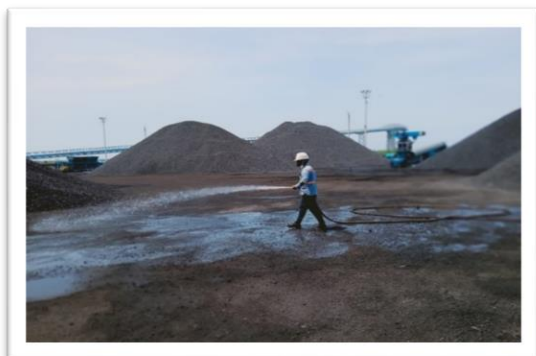
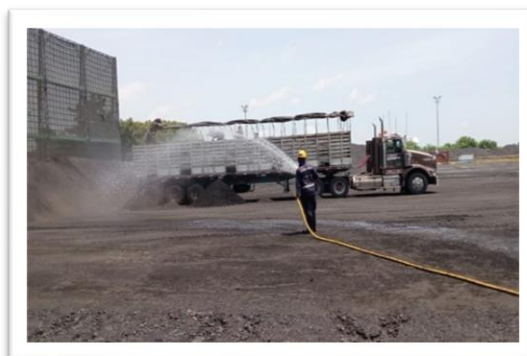
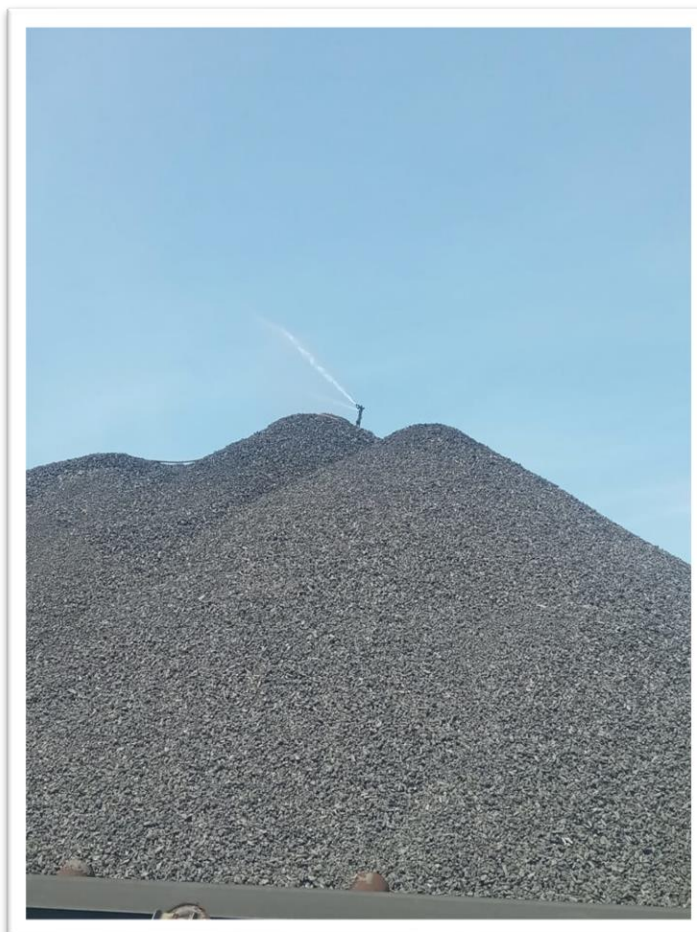
Imagen No 11, 12 y 13. Humectación Patio Carbón

During the first semester, Riverport continued its efforts to control and mitigate the deterioration of air quality caused by particulate matter emissions from handling coal, coke, and other bulk solids. The main activities to reduce these emissions included wetting the coal in the yard, applying water upon entering the yard, and washing vehicles after unloading.

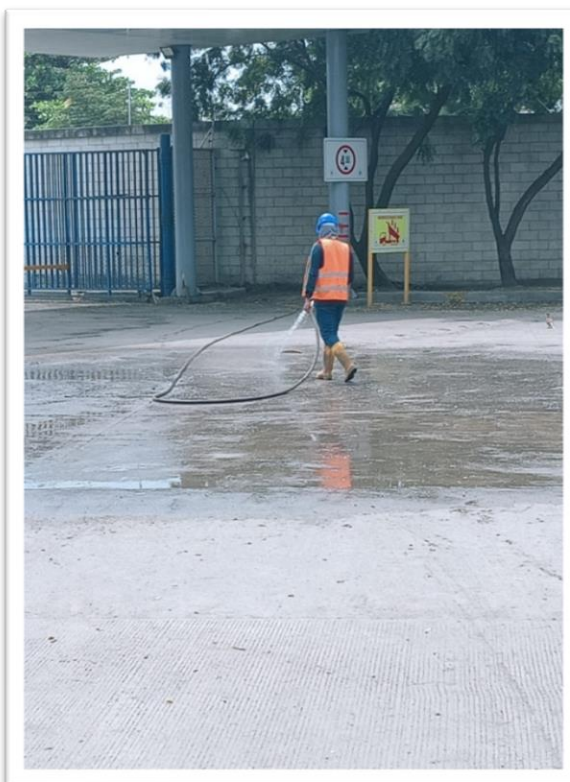
Imagen No 14, 15 y 16 Humectación vías externas e internas

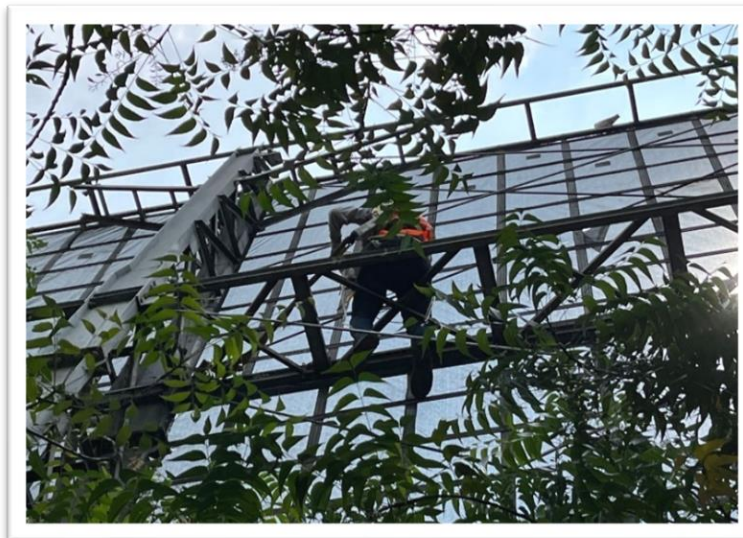
Imagen No 17 y 18. Mantenimiento Barrera Ambiental

During the first semester of 2024, maintenance activities for the environmental barrier continued, including the replacement of fasteners and the substitution of tarps in deteriorated sections. Additionally, periodic washing of the barrier was performed when a certain level of clogging in the tarp was detected.

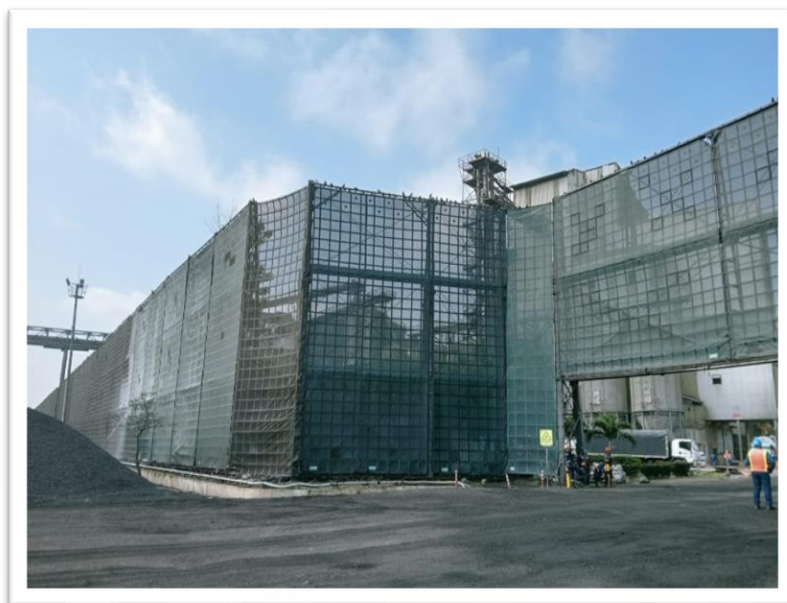
Imagen No 19,20 y 21. Lavado Barrera Ambiental

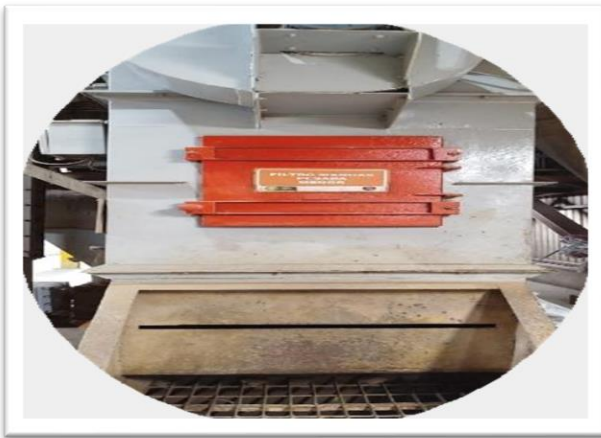
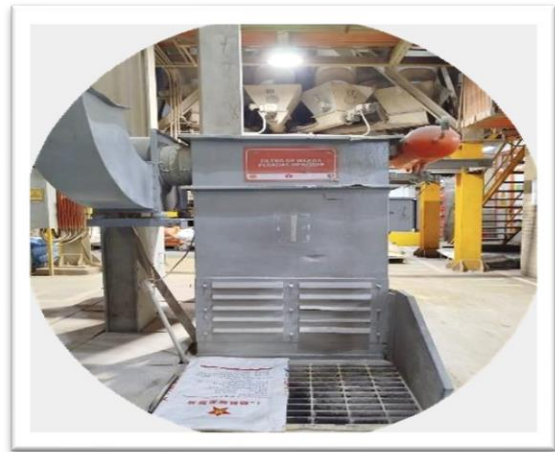
Imagen No 22 y 23 Filtros de mangas ITALCOL S.A. Planta Barranquilla

During the first semester of 2024, the Maintenance Department conducted follow-up and preventive maintenance on emission control systems as part of its preventive maintenance plan. This was done to maintain the efficiency of these systems and reduce atmospheric emissions.

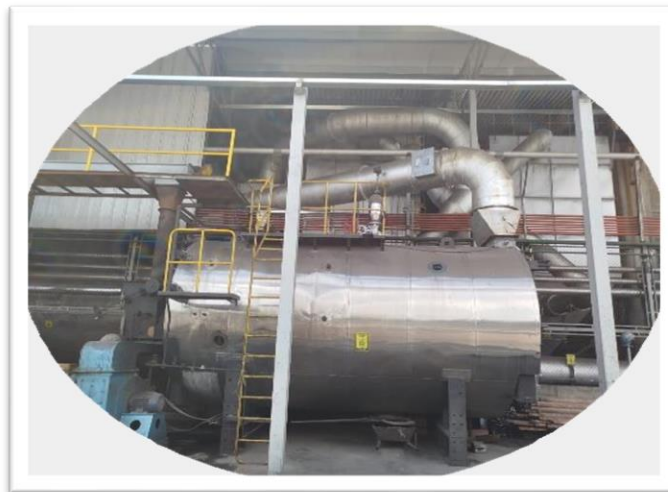
Imagen No 24 Ciclones y Multiciclón de la caldera

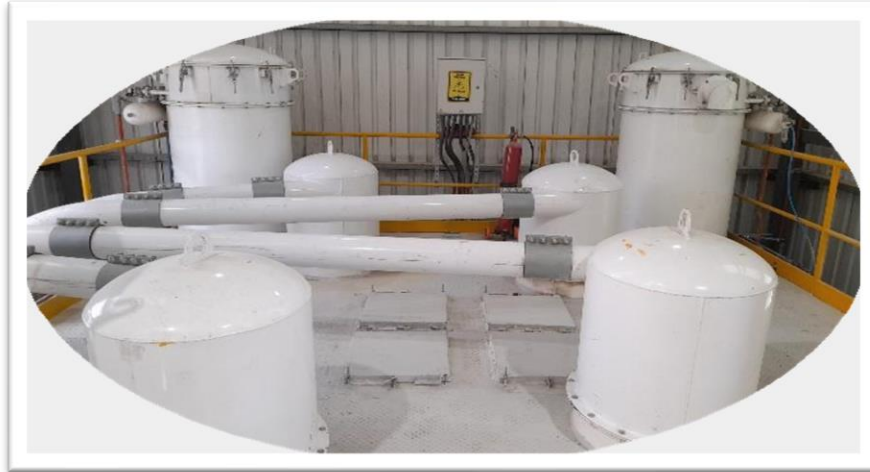
Imagen No 25. Filtros manga de la extruder Ferraz 10

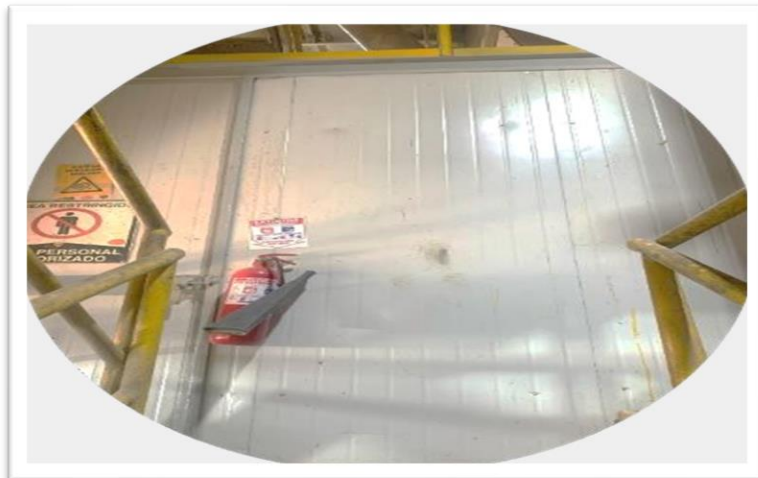
Imagen No 26. Cabina insonora de los molinos de producción

For noise emission control, monthly measurements are conducted as an internal follow-up measure to monitor noise emissions. Additionally, maintenance and monitoring are performed on the soundproof cabins installed on equipment that generates higher decibel levels during the concentrated animal feed production process. Furthermore, during this semester, the soundproof cabin material was upgraded with mineral rock wool panels to enhance sound insulation and minimize the generated decibels.

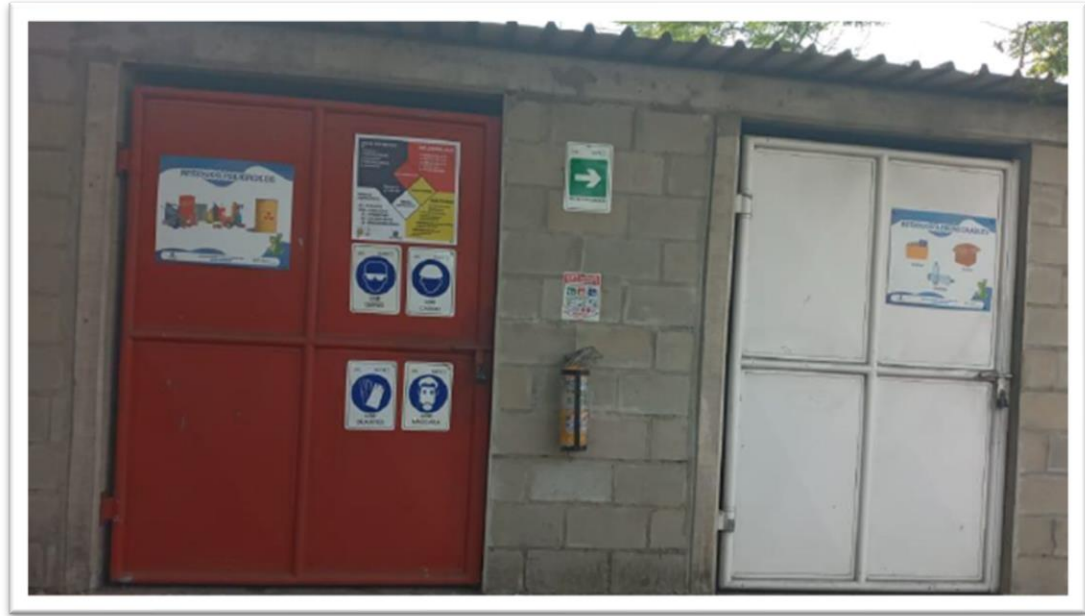
Imagen No 27. Centro de Acopio de residuos Riverport.

All the aforementioned waste is separated at the source through the various ecological points installed in the generation areas and is then transported to the collection center located within our facilities for temporary storage before its recovery, treatment, or final disposal.
